**Flood Control Project Maintenance
Levee Inspections****LMA District Cover Sheet****Spring 2011 Levee Inspection Results****Reclamation District No. 0524 Middle Roberts Island**

Levee Inspection Report By Mile - Spring 2011

Reclamation District No. 0524 Middle Roberts Island

| Waterway | | | | | | Bank | Unit Miles | Inspection Start/End | Inspector | |
|---|---|---|---|---|---|---|--|---|---|---|
| Unit No. 01 San Joaquin River | | | | | | Left | 6.26 | 04/06/2011 04/12/2011 | Richard Willoughby | |

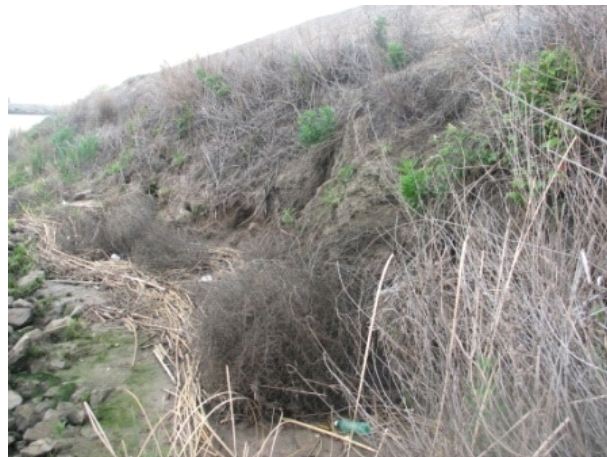
richard_s_20110215_137.jpg

Minor erosion from LM 0.38 to 0.39

| Waterway | | | | | | Bank | Unit Miles | Inspection Start/End | Inspector | |
|---|---|---|---|---|---|---|--|---|---|---|
| 6 | 0.38 | 0.39 | Earthen Levee | Erosion / Bank Caving | WS | M | Note and monitor erosion site. | 37.938527 ° -121.340887 ° | 37.938553 ° -121.340778 ° | 4 Y |

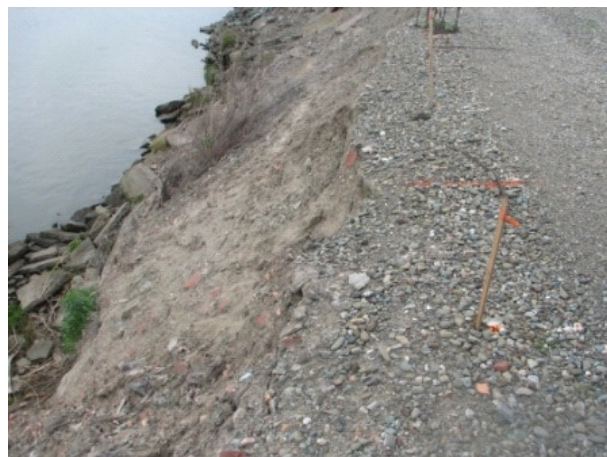
richard_s_20110215_138.jpg

Major erosion from LM 0.48 to 0.49

| Waterway | | | | | | Bank | Unit Miles | Inspection Start/End | Inspector | |
|---|---|---|---|---|---|---|--|---|---|---|
| 7 | 0.48 | 0.49 | Earthen Levee | Erosion / Bank Caving | WS | U | Schedule repair of erosion site prior to the next inspection. | 37.938693 ° -121.339063 ° | 37.938693 ° -121.338993 ° | 6 Y |

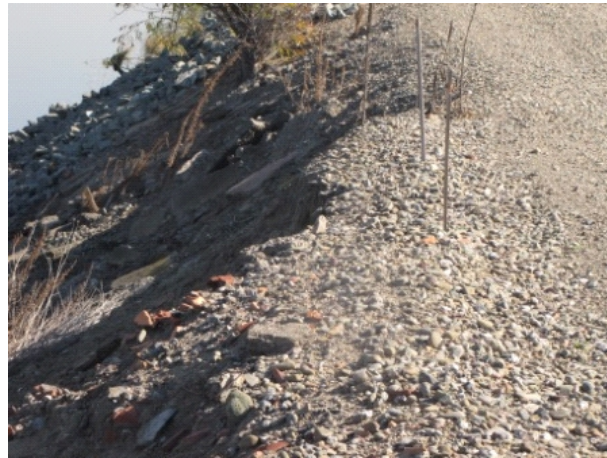
richard_s_20110215_139.jpg

Update of erosion site at LM 0.48 to 0.49

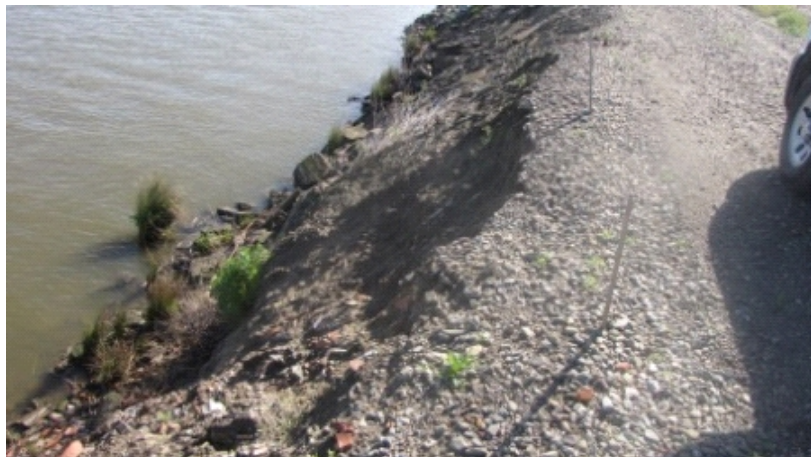
richard_s_20110215_140.jpg

Looking southeast at erosion (no change as 4/2010)

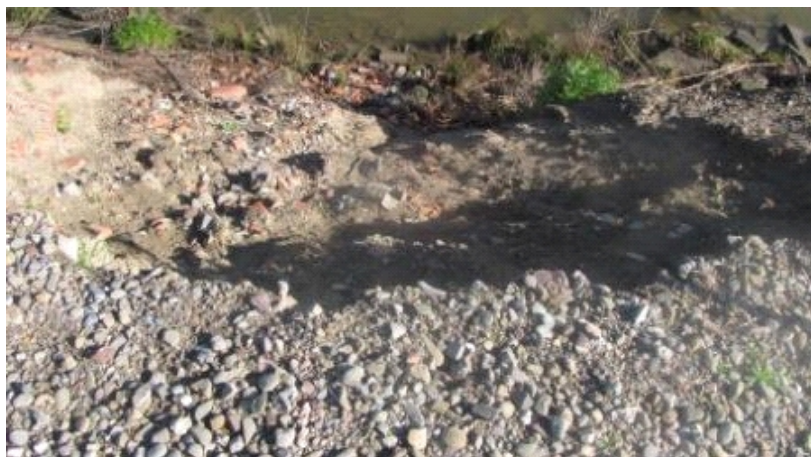
richard_s_20110215_141.jpg

Looking at erosion from the top of the levee (no change as of 4/2010)

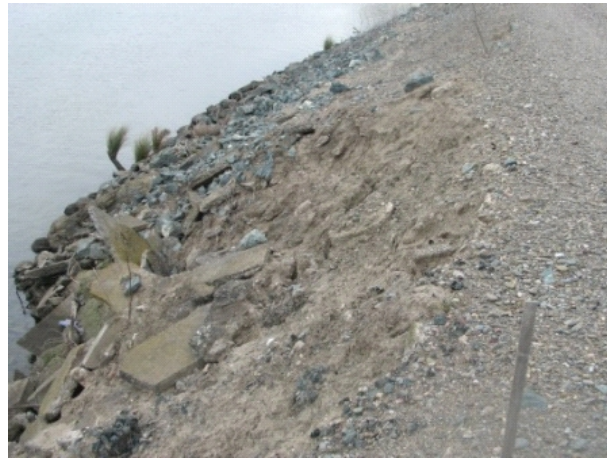
richard_s_20110215_142.jpg

Erosion from LM 0.51 to 0.52

| Waterway | | | | | | Bank | Unit Miles | Inspection Start/End | Inspector | |
|---|---|---|---|---|---|---|--|---|---|---|
| 8 | 0.51 | 0.52 | Earthen Levee | Erosion / Bank Caving | WS | U | Schedule repair of erosion site prior to the next inspection. | 37.938682 ° -121.338518 ° | 37.938657 ° -121.338425 ° | 7 Y |

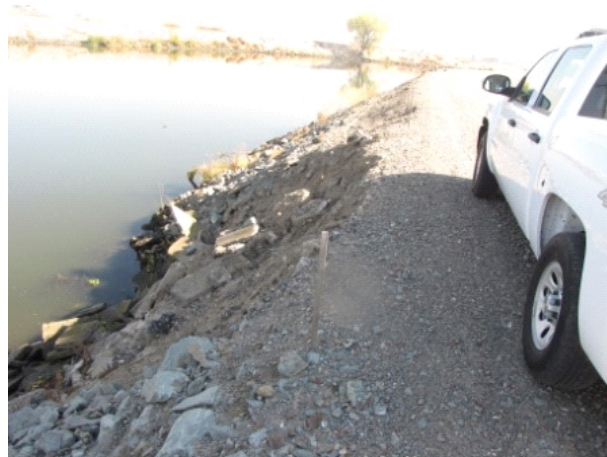
richard_s_20110215_143.jpg

Update of erosion site at LM 0.51 to 0.52

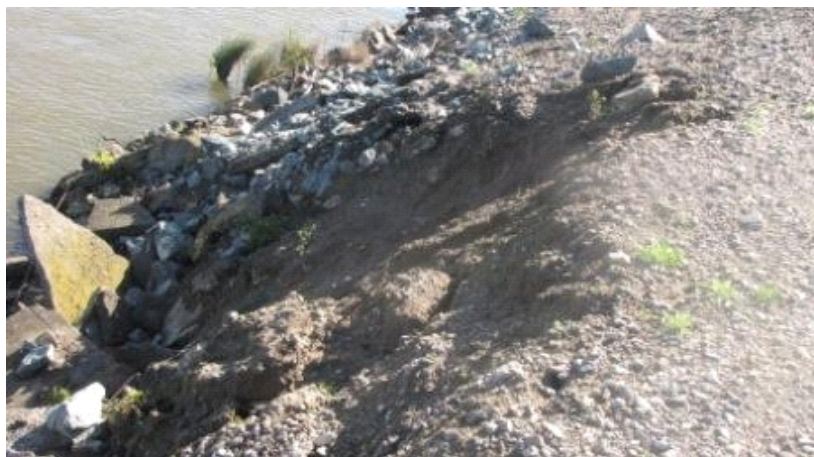
richard_s_20110215_144.jpg

Looking southeast at erosion on waterside slope ,
no change as of 4/2010)

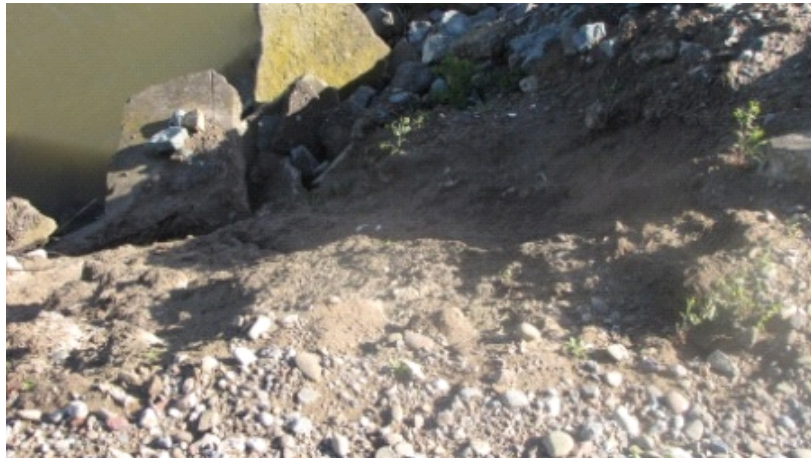
richard_s_20110215_145.jpg

Looking at erosion from the top of the levee. No change as of 4/2010

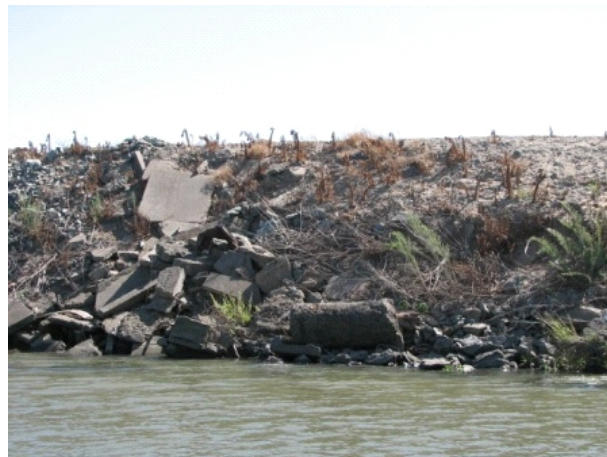
richard_s_20110215_129.jpg

| Waterway | | | | | | Bank | Unit Miles | Inspection Start/End | Inspector | |
|---|---|---|---|---|---|---|--|---|---|---|
| 9 | 0.53 | 0.60 | Supplemental | DWR Erosion Survey | WS | U | Inspector Comments: 09/07/2010: No significant changes observed on site. Some emergent vegetation at the lower and middle slope. Existing revetment is no longer adequately protecting the oversteepened slope. Some of the broken concrete used as revetment has slid, dragging levee materials away from the slope and creating notches. [2010 SiteID: RD0524U01RM41.15] | 37.938895 ° -121.337602 ° | 37.938895 ° -121.337602 ° | 1 Y |

Upstream view of site. Some of the broken concrete used as revetment is sliding, dragging down levee materials.

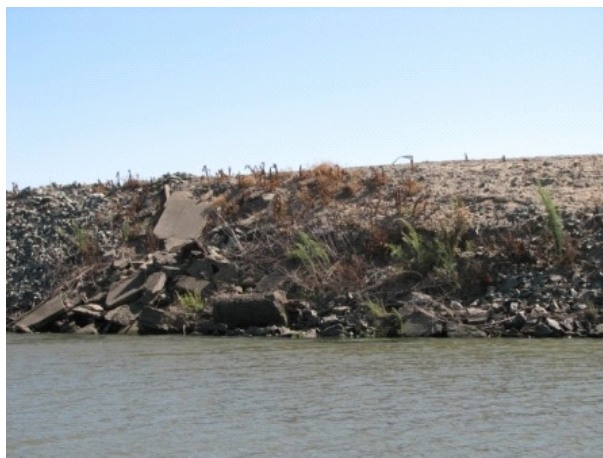
richard_s_20110215_131.jpg

Upstream view. Sloughing mid-slope possibly caused by sliding of the revetment.

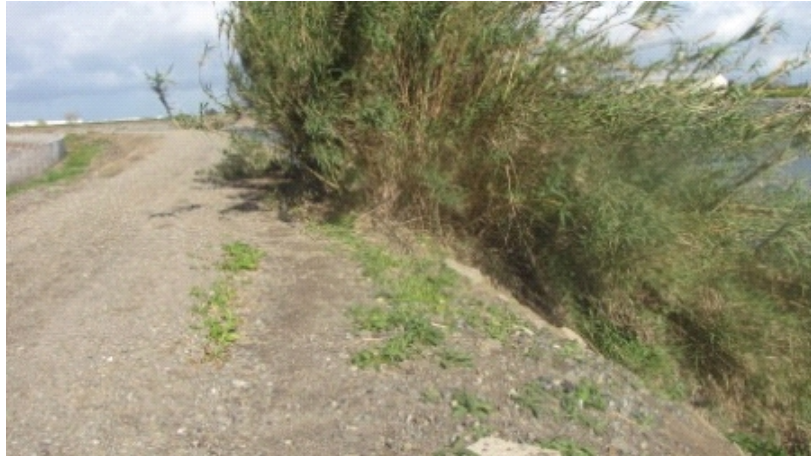
richard_s_20110215_147.jpg

Looking north at bamboo on waterside slope as of 4/2010 no change.

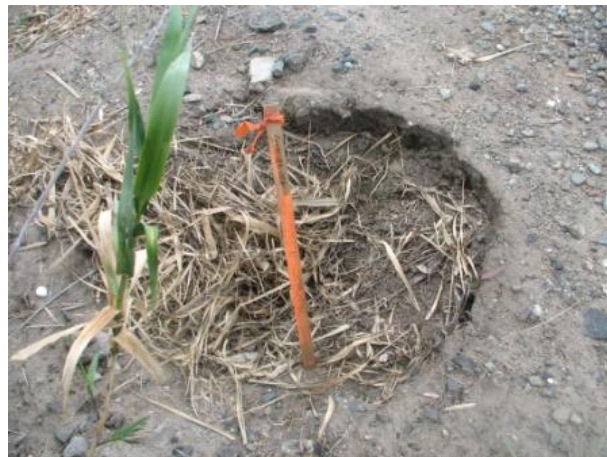
richard_s_20110215_148.jpg

Large hole 3 x 3 on levee crown near waterside shoulder at LM 0.64

| Waterway | | | | | | Bank | Unit Miles | Inspection Start/End | Inspector | |
|---|---|---|---|---|---|---|--|---|---|---|
| 12 | 0.64 | 0.64 | Earthen Levee | Crown Surface / Depressions / Rutting | CR | M | Regrade the crown roadway for proper drainage. | 37.938198 ° -121.336407 ° | 37.938198 ° -121.336407 ° | 12 Y |

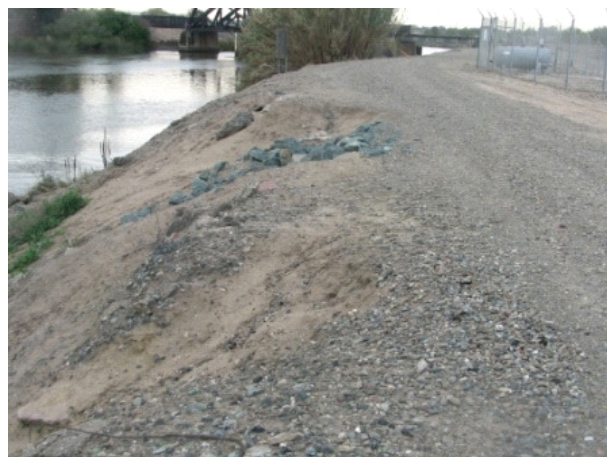
richard_s_20110215_149.jpg

Erosion from LM 0.65 to 0.66

| Waterway | | | | | | Bank | Unit Miles | Inspection Start/End | Inspector | |
|---|---|---|---|---|---|---|--|---|---|---|
| 13 | 0.65 | 0.66 | Earthen Levee | Slope Stability | WS | M | Repair slope instability. | 37.938105 ° -121.336288 ° | 37.938023 ° -121.336173 ° | 13 Y |

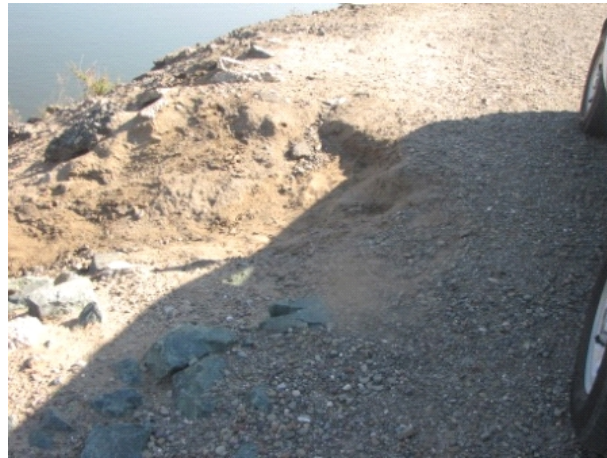
richard_s_20110215_150.jpg

Update of erosion site at LM 0.65 to 0.66

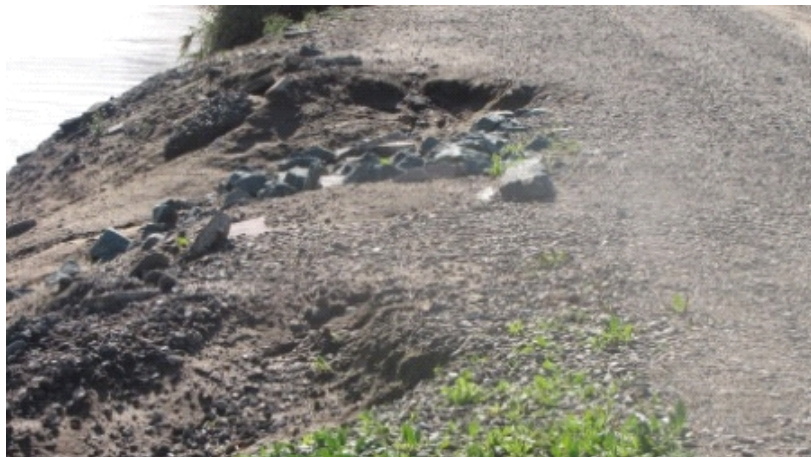
richard_s_20110215_151.jpg

Looking south at erosion on waterside shoulder.

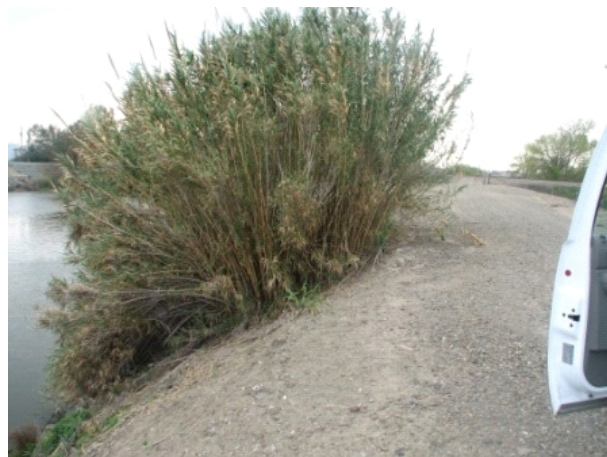
richard_s_20110215_152.jpg

Bamboo on waterward slope at LM 0.68

| Waterway | | | | | | Bank | Unit Miles | Inspection Start/End | Inspector | |
|---|---|---|---|---|---|---|--|---|---|---|
| 14 | 0.68 | 0.68 | Earthen Levee | Vegetation | WS | U | Remove the wild growth other than native grasses from the levee slopes. | 37.937808 ° -121.335913 ° | 37.937808 ° -121.335913 ° | 14 Y |

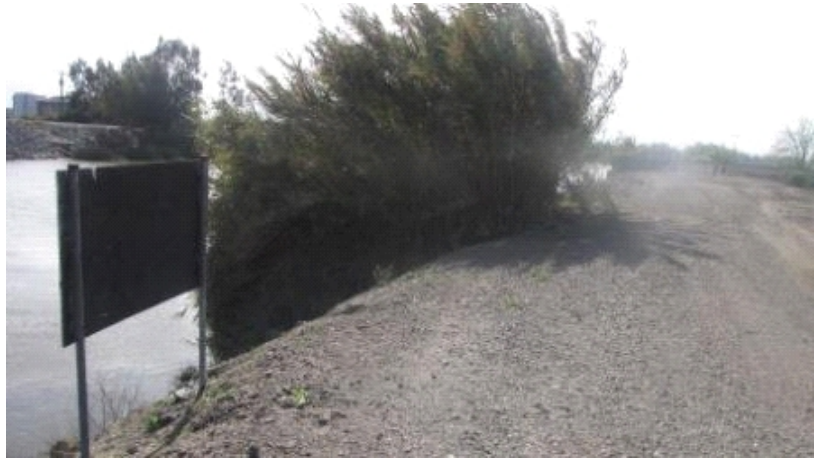
richard_s_20110215_153.jpg

Looking southeast at bamboo on waterside shoulder as of 4/2010.

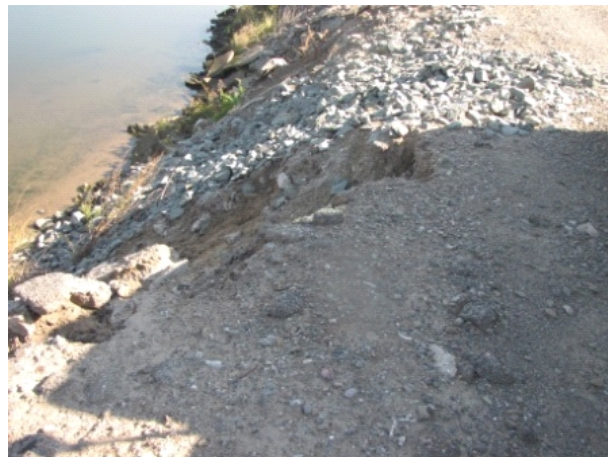
richard_s_20110215_155.jpg

Looking upstream (south) at erosion site.

| Waterway | | | | | | | Bank | Unit Miles | Inspection Start/End | Inspector |
|---|---|---|---|---|---|---|---|---|---|---|
| 18 | 1.03 | 1.03 | Earthen Levee | Erosion / Bank Caving | WS | M | Schedule repair of erosion site prior to the next inspection. | 37.935018 ° -121.331248 ° | 37.935098 ° -121.331645 ° | 17 Y |

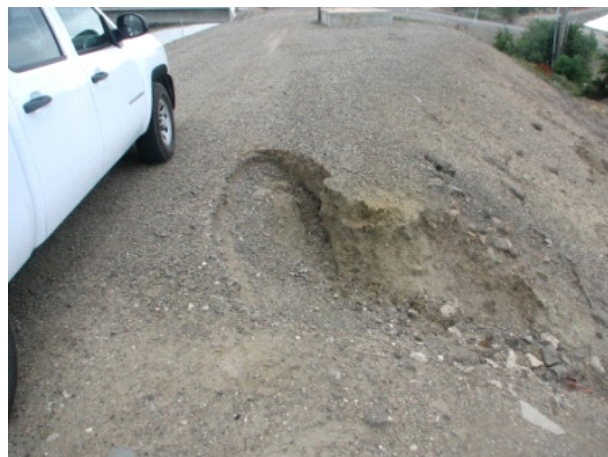
richard_s_20110215_156.jpg

Landward slope damage at LM 1.09

| Waterway | | | | | | | Bank | Unit Miles | Inspection Start/End | Inspector |
|---|---|---|---|---|---|---|---|---|---|---|
| 19 | 1.09 | 1.09 | Earthen Levee | Slope Stability | LS | M | Repair slope instability. | 37.934645 ° -121.330310 ° | 37.934645 ° -121.330310 ° | 18 Y |

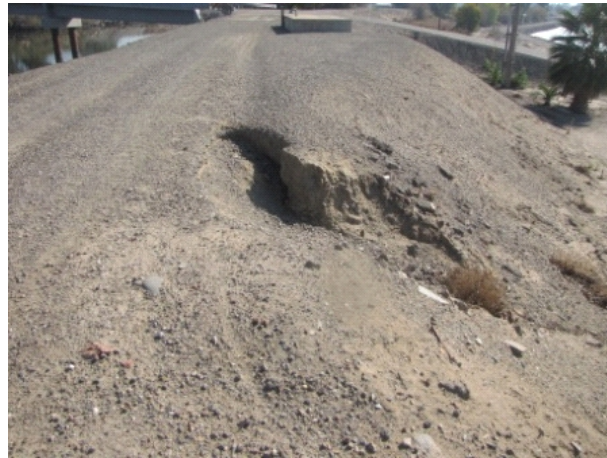
richard_s_20110215_157.jpg

Updated picture of erosion site on landside shoulder.

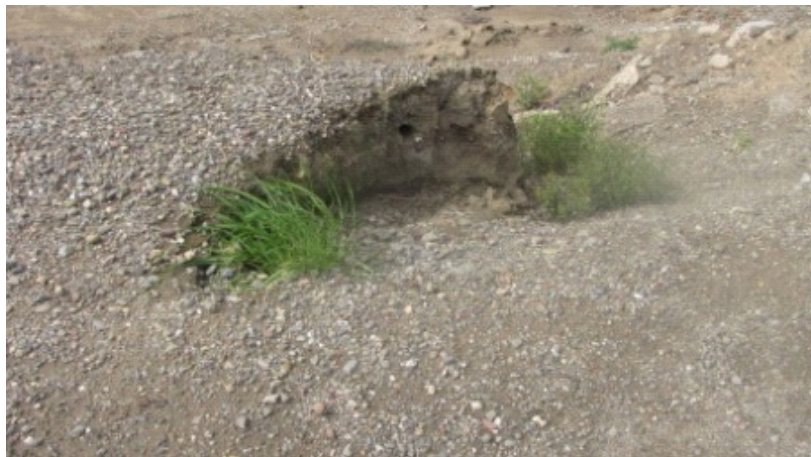
richard_s_20110215_158.jpg

Update of above slope stability.

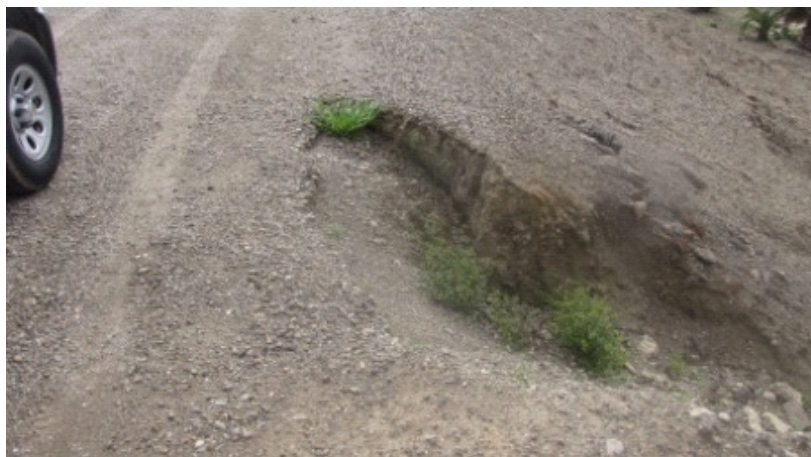
richard_s_20110215_159.jpg

Looking at updated slope stability as 4/2010

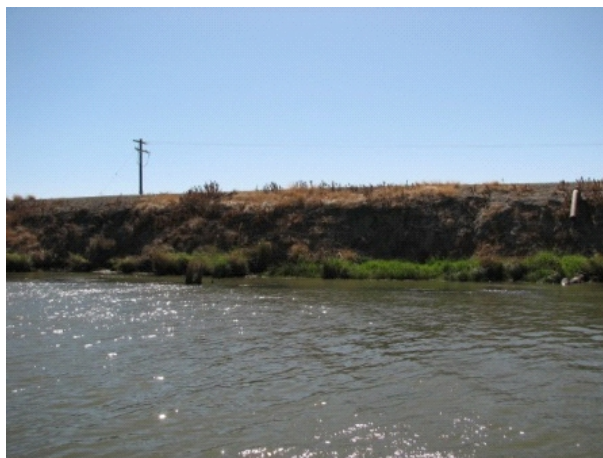
richard_s_20110215_133.jpg

| Waterway | | | | | | | Bank | Unit Miles | Inspection Start/End | Inspector |
|---|---|---|---|---|---|---|---|---|---|---|
| 21 | 1.16 | 1.24 | Supplemental | DWR Erosion Survey | WS | U | Inspector Comments: 9/07/2010: No significant changes observed on site. Some emergent vegetation at the water line. There is an exposed pipe discharge partially hanging at the mid-slope, possibly still used for discharging irrigation/runoff water. There is minimal rip rap protection along the bank, and what's left of it is no longer adequately protecting the bank. [2010 SiteID: RD0524U01RM41.79] | 37.933347 ° -121.329110 ° | 37.933347 ° -121.329110 ° | 2 Y |

Upstream view of site where sloughing is occurring.

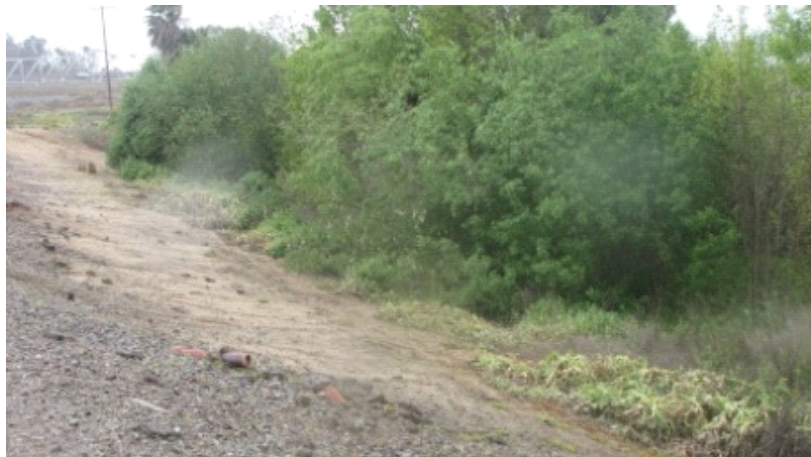
richard_s_20110215_204.jpg

Looking southwest at dense veg. on landside toe.

| Waterway | | | | | | | Bank | Unit Miles | Inspection Start/End | Inspector |
|---|---|---|---|---|---|---|---|---|---|---|
| 22 | 1.17 | 1.25 | Earthen Levee | Vegetation | LS | M | Remove the wild growth other than native grasses from the levee slopes. | 37.933775 ° -121.329250 ° | 37.932784 ° -121.328765 ° | 915 Y |

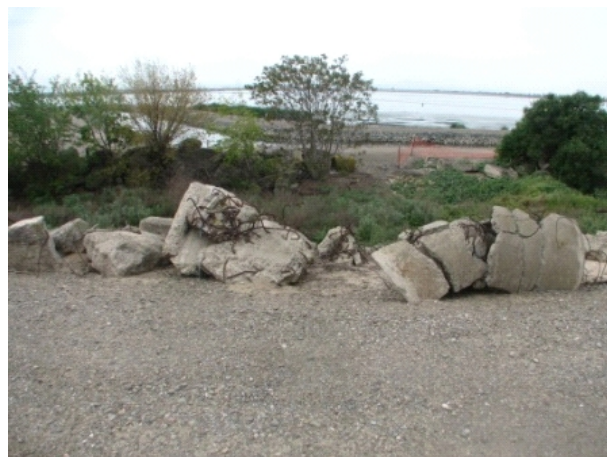
richard_s_20110215_160.jpg

Concrete rubble with rebar on landward shoulder at LM 1.25

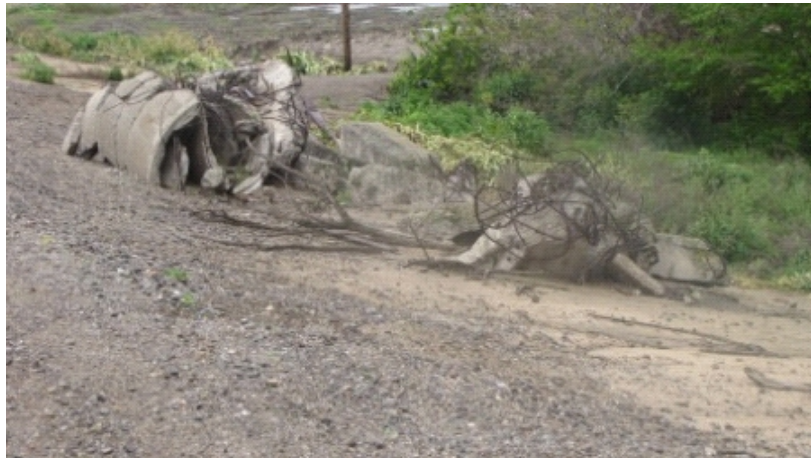
richard_s_20110215_161.jpg

Looking south at concrete rubble on landside slope.

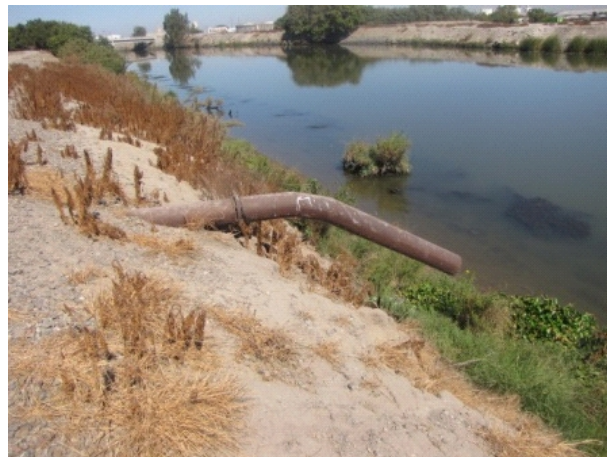
richard_s_20110215_174.jpg

| Waterway | | | | | | | Bank | Unit Miles | Inspection Start/End | Inspector |
|---|---|---|---|---|---|---|---|---|---|---|
| 24 | 1.31 | 1.31 | Earthen Levee | Encroachments | WS | M | Pipe Inspector Comments: Pipe is not in use and needs to be properly abandoned. | 37.931948 ° -121.328387 ° | 37.931948 ° -121.328387 ° | 33 Y |

Looking north at broken pipe.

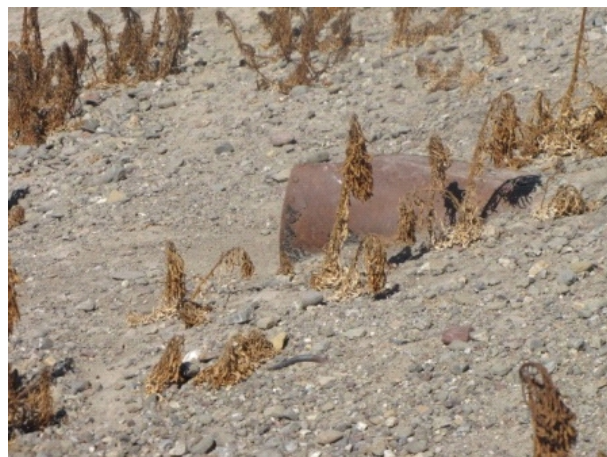
richard_s_20110215_175.jpg

Looking west at pipe on landside slope.

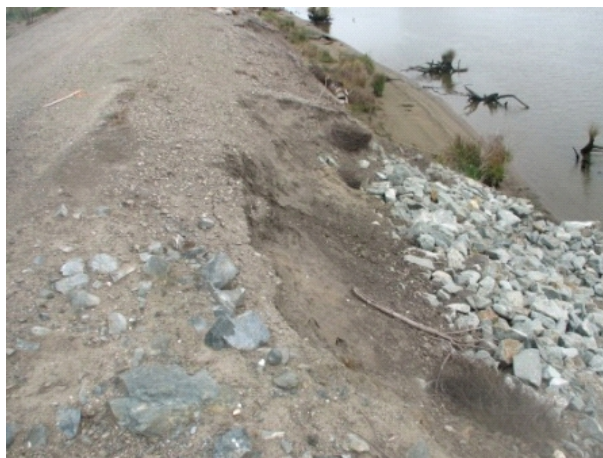
richard_s_20110215_162.jpg

Erosion from LM 1.32 to 1.33

| Waterway | | | | | | | Bank | Unit Miles | Inspection Start/End | Inspector |
|---|---|---|---|---|---|---|---|---|---|---|
| 25 | 1.32 | 1.33 | Earthen Levee | Erosion / Bank Caving | WS | M | Schedule repair of erosion site prior to the next inspection. | 37.931858 ° -121.328308 ° | 37.931692 ° -121.328282 ° | 21 Y |

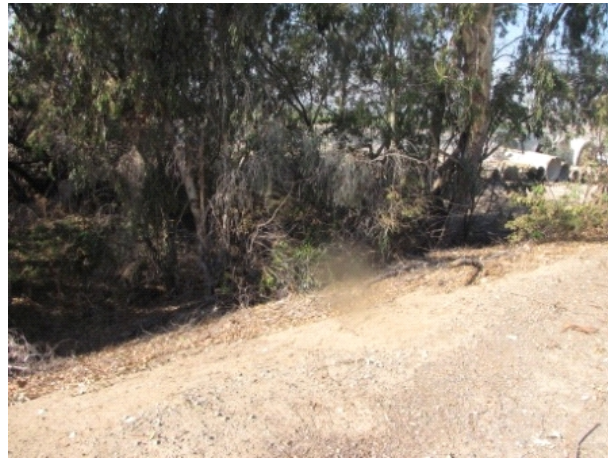
richard_s_20110215_205.jpg

Dense vegetation on landside toe.

| Waterway | | | | | | | Bank | Unit Miles | Inspection Start/End | Inspector |
|---|---|---|---|---|---|---|---|---|---|---|
| 27 | 1.51 | 1.51 | Earthen Levee | Trim / Thin Trees | LS | U | Trim and thin trees to allow visibility of the ground and room to flood fight. | 37.929118 ° -121.328368 ° | 37.929118 ° -121.328368 ° | 916 Y |

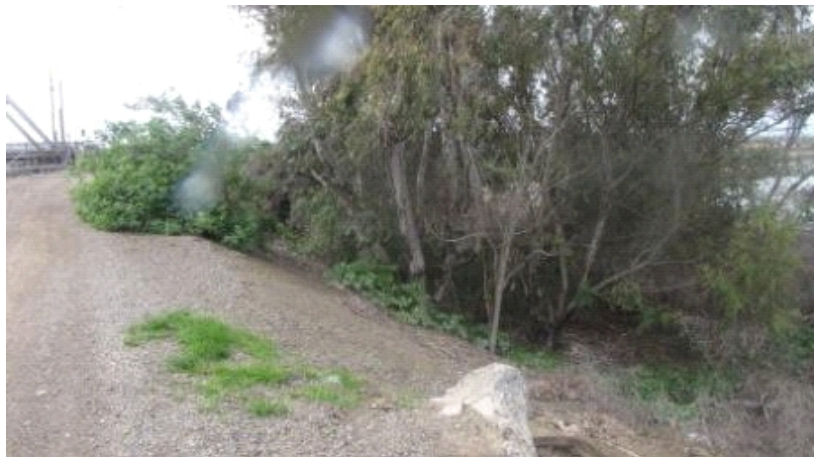
richard_s_20110215_206.jpg

Looking south at dense veg. on landside slope and toe.

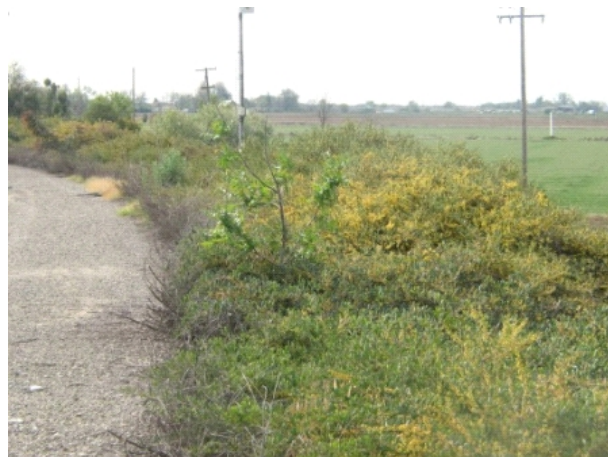
richard_s_20110215_165.jpg

Overgrown landscaping on landward slope from LM 1.56 to 1.74

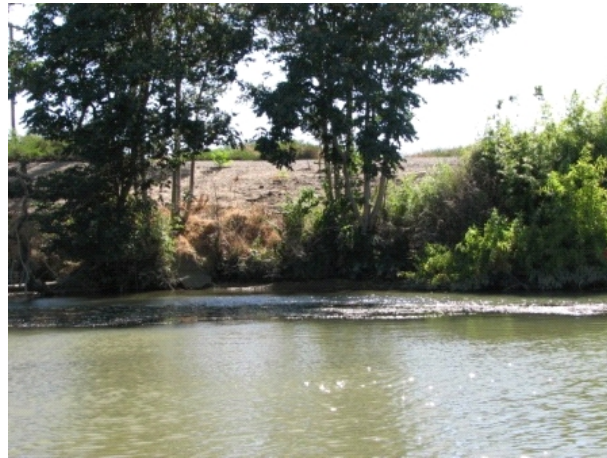
richard_s_20110215_194.jpg

| Waterway | | | | | | | Bank | Unit Miles | Inspection Start/End | Inspector |
|---|---|---|---|---|---|---|---|---|---|---|
| 29 | 1.58 | 1.64 | Supplemental | DWR Erosion Survey | WS | U | Inspector Comments: 09/07/2010: No signifcant changes observed on site. The concern here is the undermining of the levee toe where most of trees are. There are erosion pockets lined along the lower slope and at the base of the trees, exposing tree roots. There is minimal slope protection. [2010 SiteID: RD0524U01RM42.2] | 37.927770 ° -121.327870 ° | 37.927770 ° -121.327870 ° | 79 Y |

Front view of site where undermining has occurred.

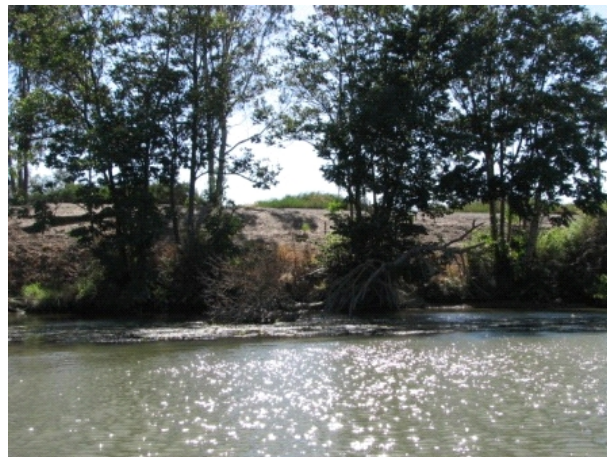
richard_s_20110215_195.jpg

Large trees along the levee toe. There is minimal slope protection.

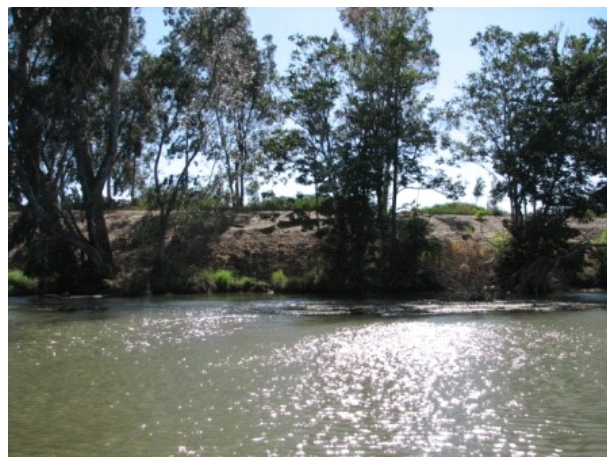
richard_s_20110215_196.jpg

Large trees along the levee toe where undermining at the toe has occurred.

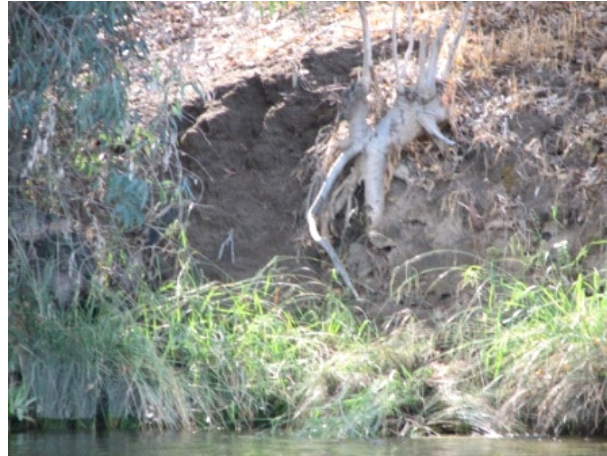
richard_s_20110215_197.jpg

Close up view of a pocket erosion that is directly affecting the base of a tree. Note the exposed tree roots. This image was taken on 09/29/2009.

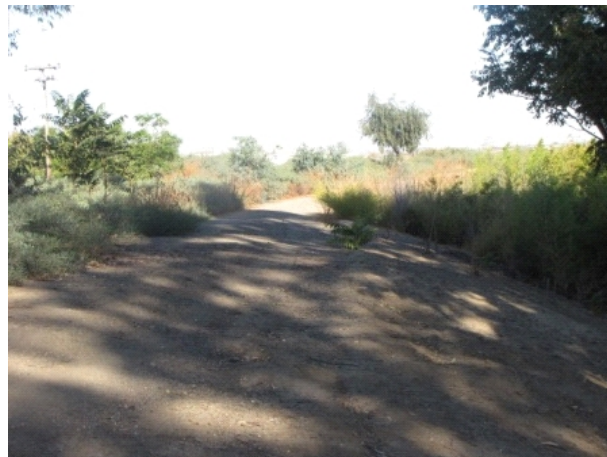
richard_s_20110215_166.jpg

Looking north at dense veg on landside and waterside slopes.

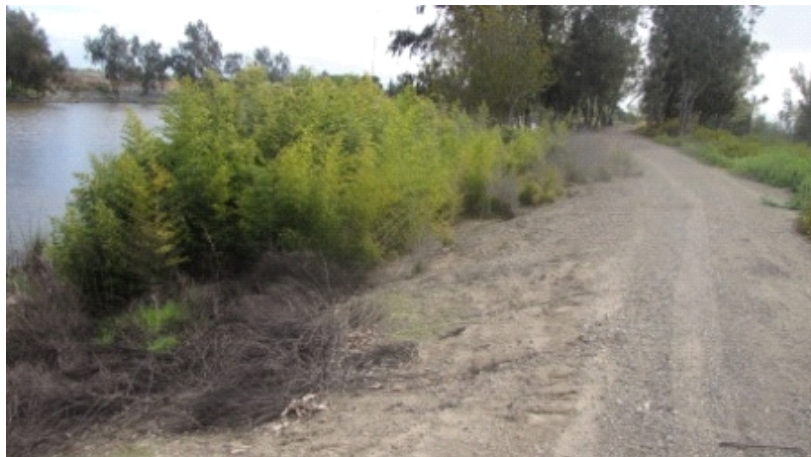
richard_s_20110215_167.jpg

Looking southeast at dense veg. on waterside slope.

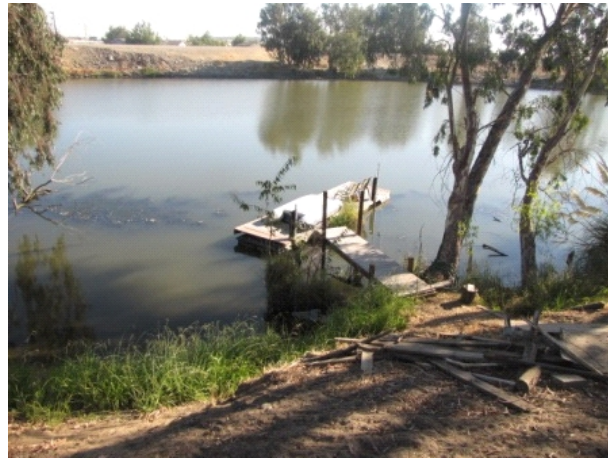
richard_s_20110215_181.jpg

Looking east at non-permitted boat dock.

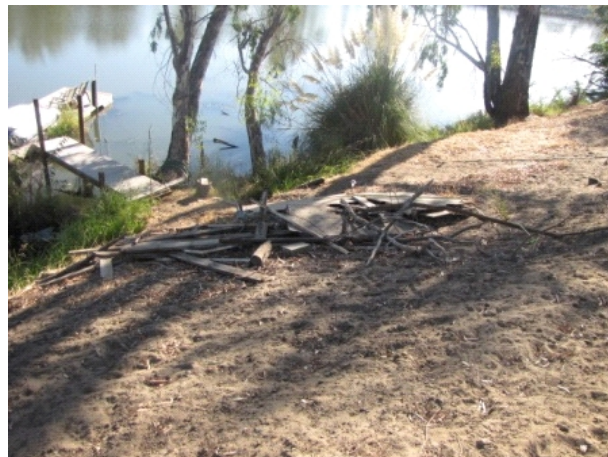
richard_s_20110215_182.jpg

Looking at garbage on waterside slope.

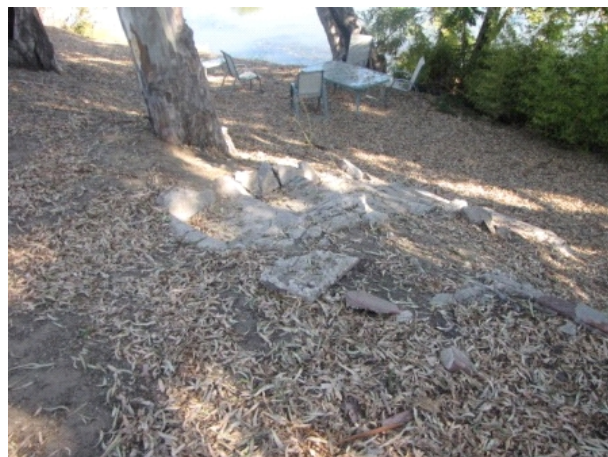
richard_s_20110215_185.jpg

Looking northeast on non-permitted concrete stairs on waterside slope.

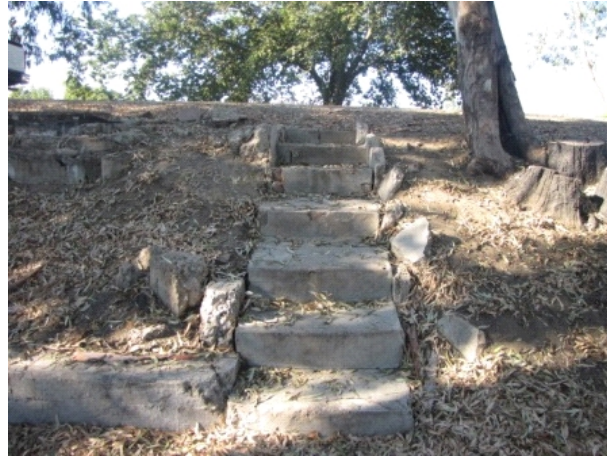
| richard_s_20110215_186.jpg | |

| Looking west at concrete stairs on waterside slope. | |

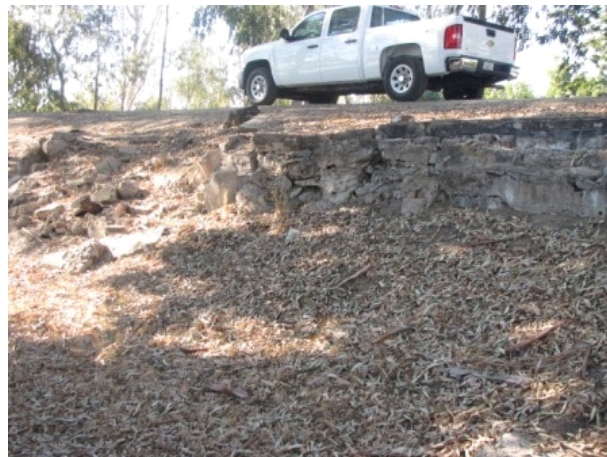
| richard_s_20110215_187.jpg | |

| Looking southwest at retaining wall connect to concrete stairs. | |

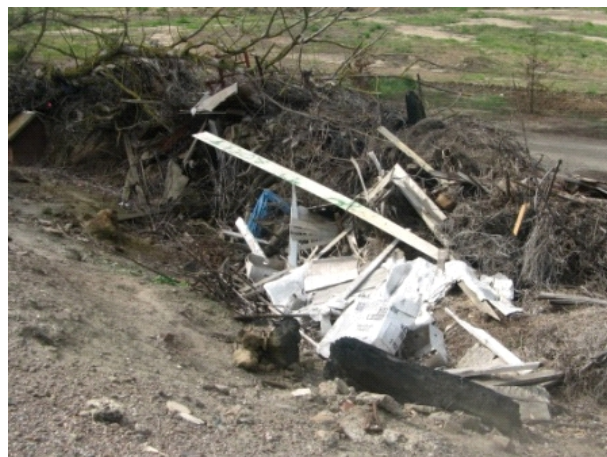
| richard_s_20110215_168.jpg | |

| Garbage on landward toe from LM 1.75 to 1.76 | |

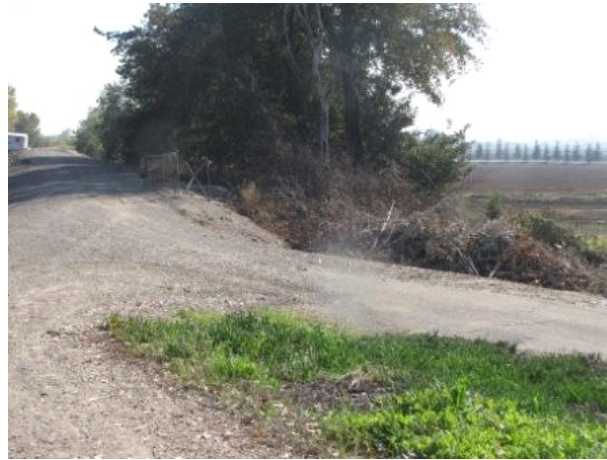
richard_s_20110215_169.jpg

Looking at updated trash pile on landside slope and toe.

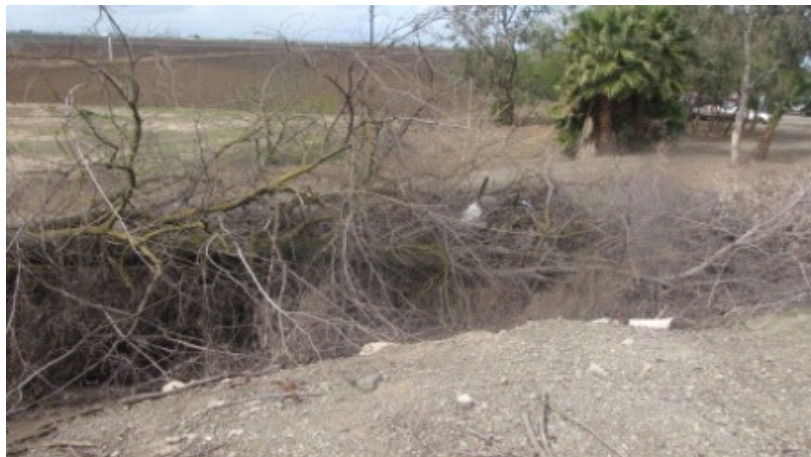
richard_s_20110215_170.jpg

Looking west at prunings on landside toe.

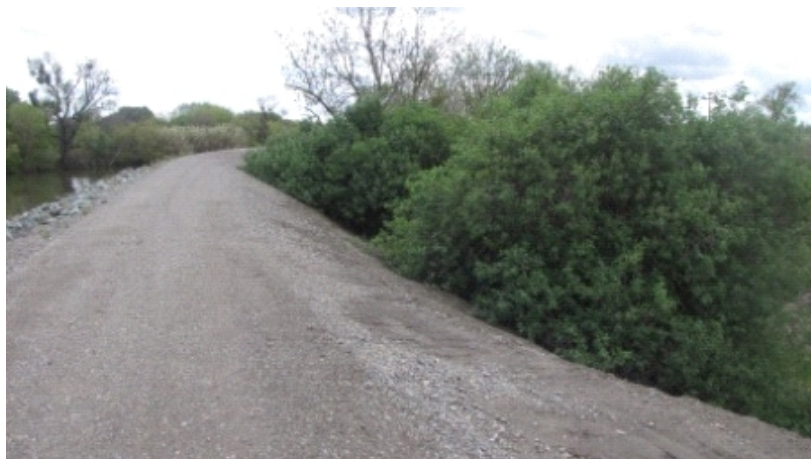
richard_s_20110215_173.jpg

Looking south at dense veg on landside slope and toe.

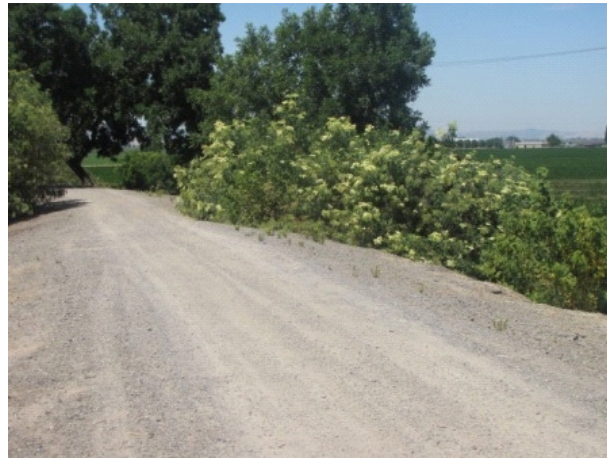
richard_s_20110215_176.jpg

Looking south at elderberry on landside slope.

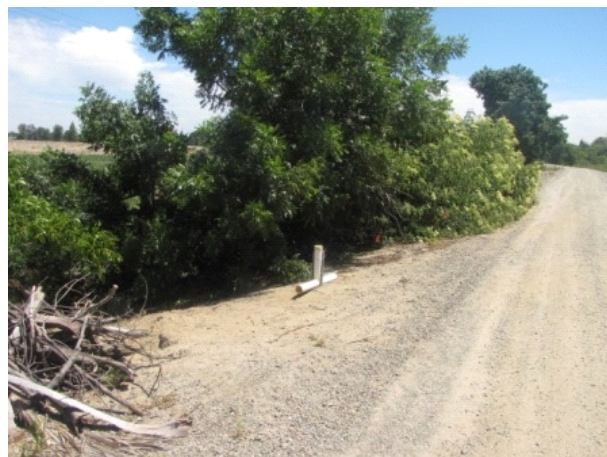
richard_s_20110215_178.jpg

Looking north at elderberry and trees on landside slope.

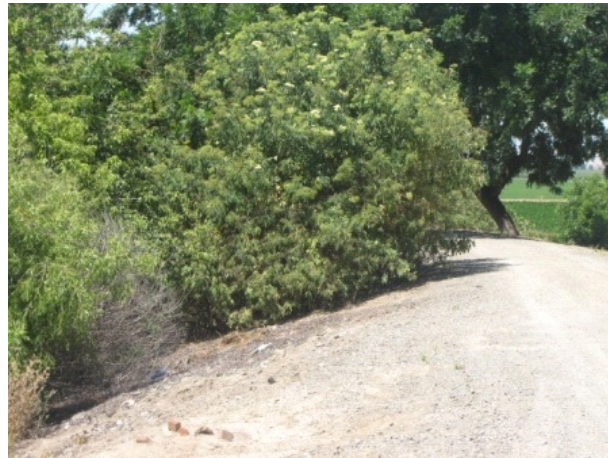
richard_s_20110215_179.jpg

Looking south at elderberry on waterside slope.

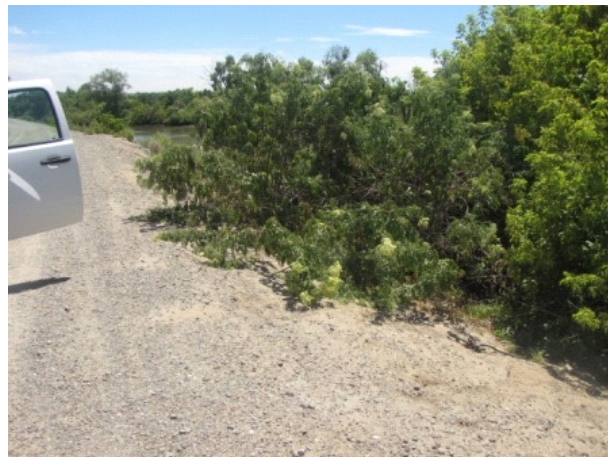
richard_s_20110215_180.jpg

Looking north at elderberry on waterside slope.

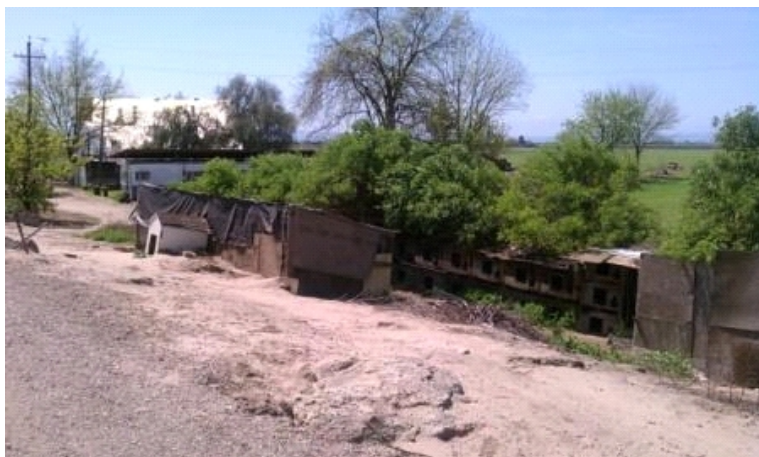
richard_s_20110525_489.jpg

Looking at animal pens on landside slope and toe.

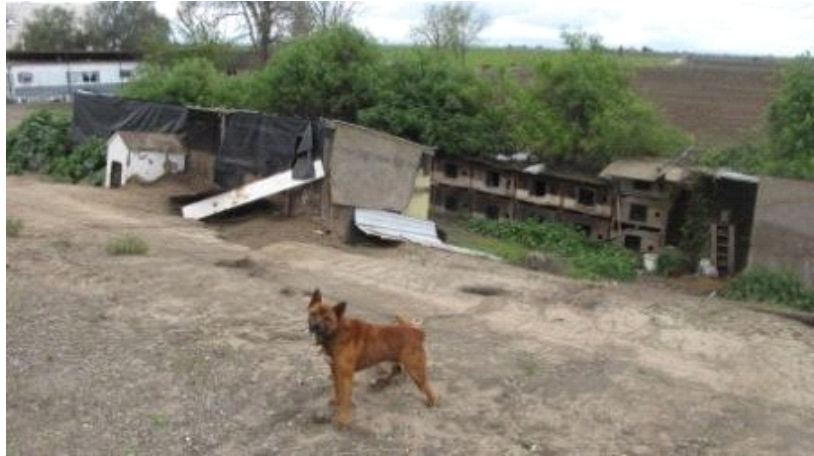
| richard_s_20110215_184.jpg | |

| Looking southwest at structures on landside. | |

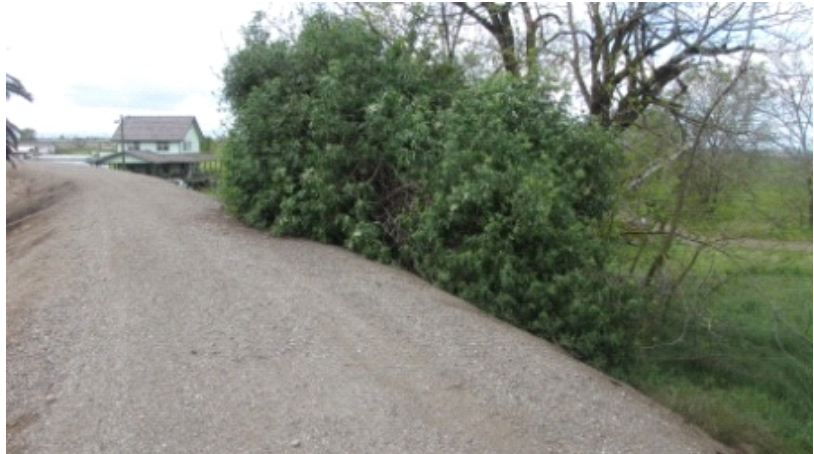
| richard_s_20110215_189.jpg | |

| Looking south at elderberry on landside slope. | |

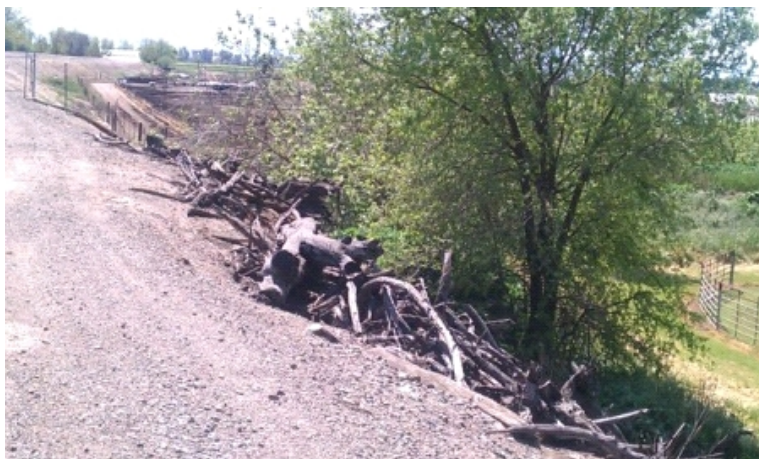
| richard_s_20110418_488.jpg | |

| Looking southwest at prunings on landside slope. | |

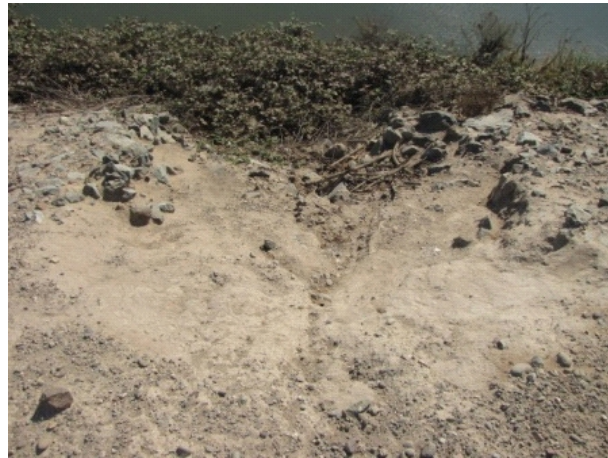
richard_s_20110215_207.jpg

Looking east at erosion on waterside toe.

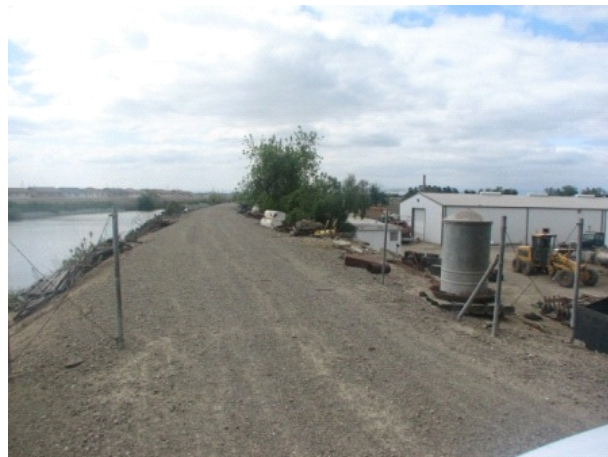
richard_s_20110215_190.jpg

Looking upstream at equipment on landside shoulder

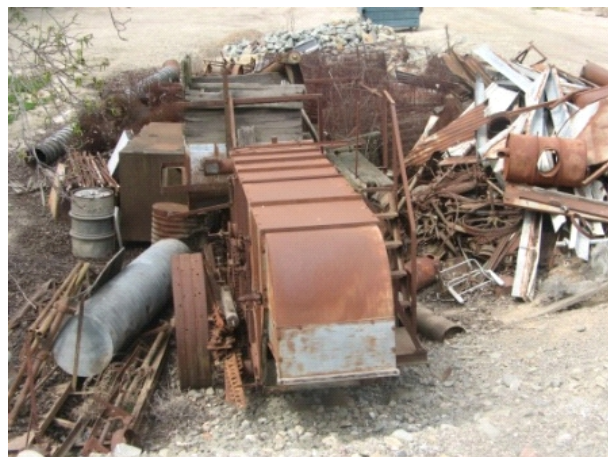
richard_s_20110215_191.jpg

Garbage at landward toe next to ramp at LM 4.64

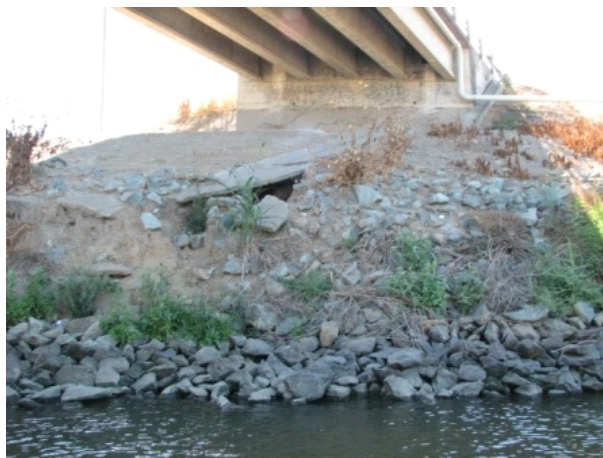
richard_s_20110215_200.jpg

| Waterway | | | | | | | Bank | Unit Miles | Inspection Start/End | Inspector |
|---|---|---|---|---|---|---|---|---|---|---|
| 107 | 5.65 | 5.66 | Supplemental | DWR Erosion Survey | WS | M | Inspector Comments: 09/07/2010: No significant changes observed on site. Erosion site is located beneath Howard Road Bridge. Majority of the existing rip rap has slipped, dragging away levee materials and exposing the underlying soft soil. 08/06/2010: Recommend for annual assessment and monitoring during flood events, per CLRO. [2010 SiteID: RD0524U01RM46.12] | 37.877880 ° -121.332550 ° | 37.877880 ° -121.332550 ° | 90 Y |

Sloughing rip rap just below the Howard Bridge abutment.

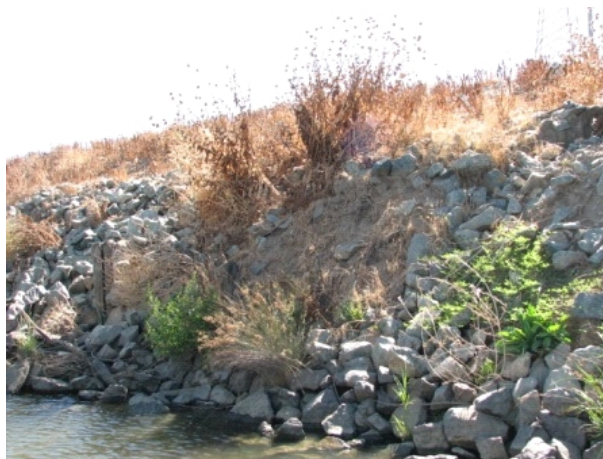
richard_s_20110215_201.jpg

Upstream view of the sloughing rip rap adjacent to Howard Bridge.
